# Secumat® - Heidlandgraben - Germany

Erosion Control in a Drainage Channel

- **Project Name**  
Heidlandgraben, Heykenauweg, Hamburg, Germany
- **Product**  
Secumat® 601 G4  
Secutex® 301 GRK 5 C

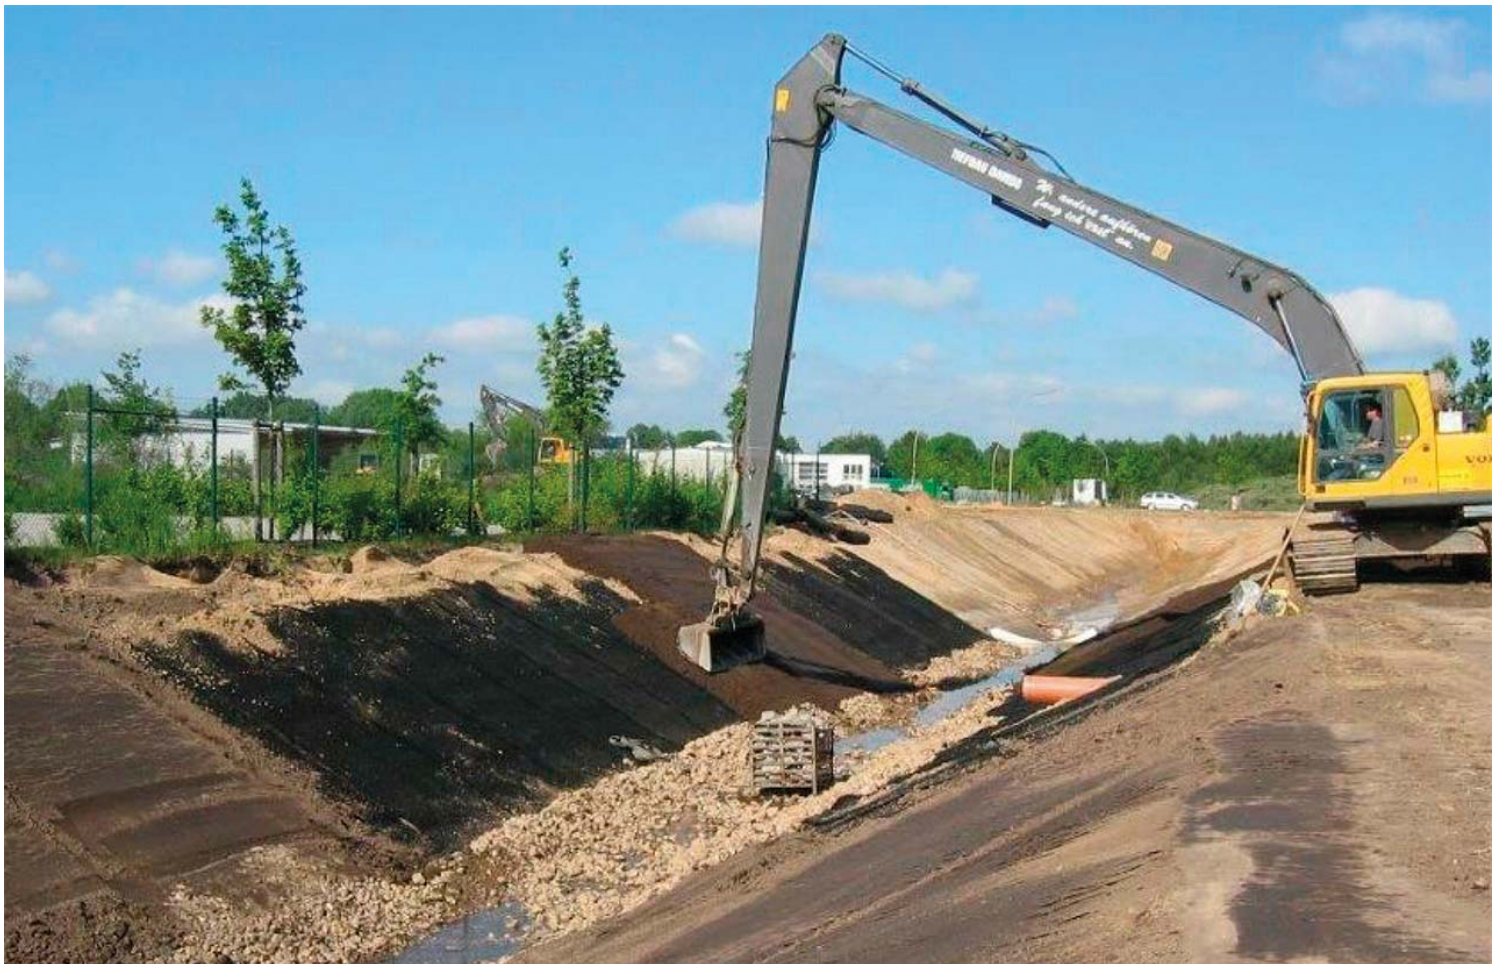
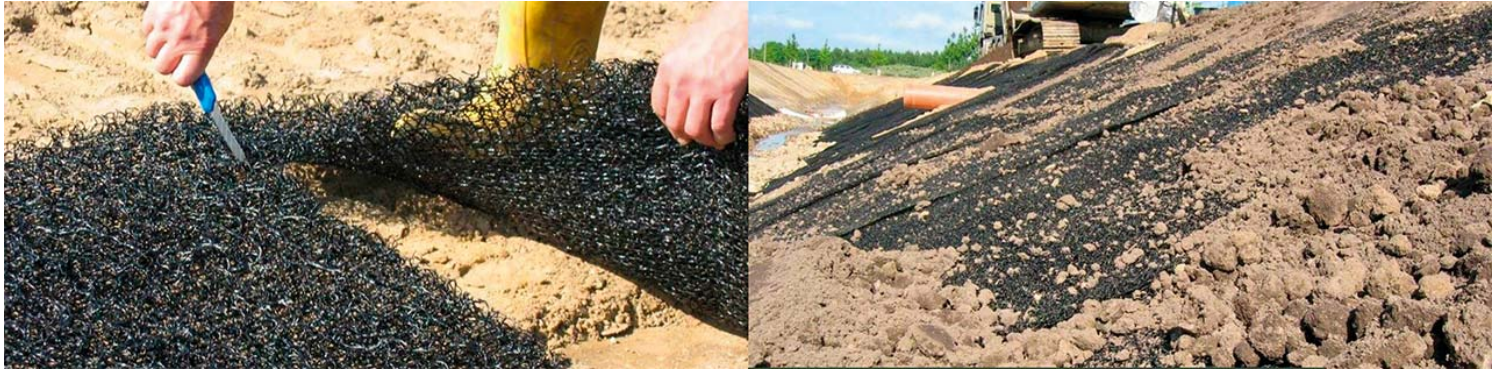
The erosion control mat was cut to size on site to the appropriate length for the slope (plus anchor trench). Due to its low weight, the material was installed by hand. The backfilling was carried out using a long arm excavator from the accessible side of the channel. Armourstones were placed in the bottom of the channel. To effectively prevent the sandy subsoil from being washed out through the coarse backfill even in the event of a substantial rise in the water level, a Secutex® separation and filter nonwoven was installed on the subgrade in advance.

The positive effect of Secumat® was already evident during the construction phase. During heavy rainfall events, the difference between embankment areas already finished with Secumat® and topsoil and the areas not yet worked on became clear. On the slopes that had already been profiled but not yet covered with Secumat® and new topsoil, deep erosion grooves formed in some cases due to surface water collecting and running off, while the areas newly constructed with Secumat® did not show any significant erosion.
