Secugrid® HS

Basal reinforced embankments

Reconstruction of Oder dyke in Uckermark county,
Polder 5/6, Part 15, Lot 67

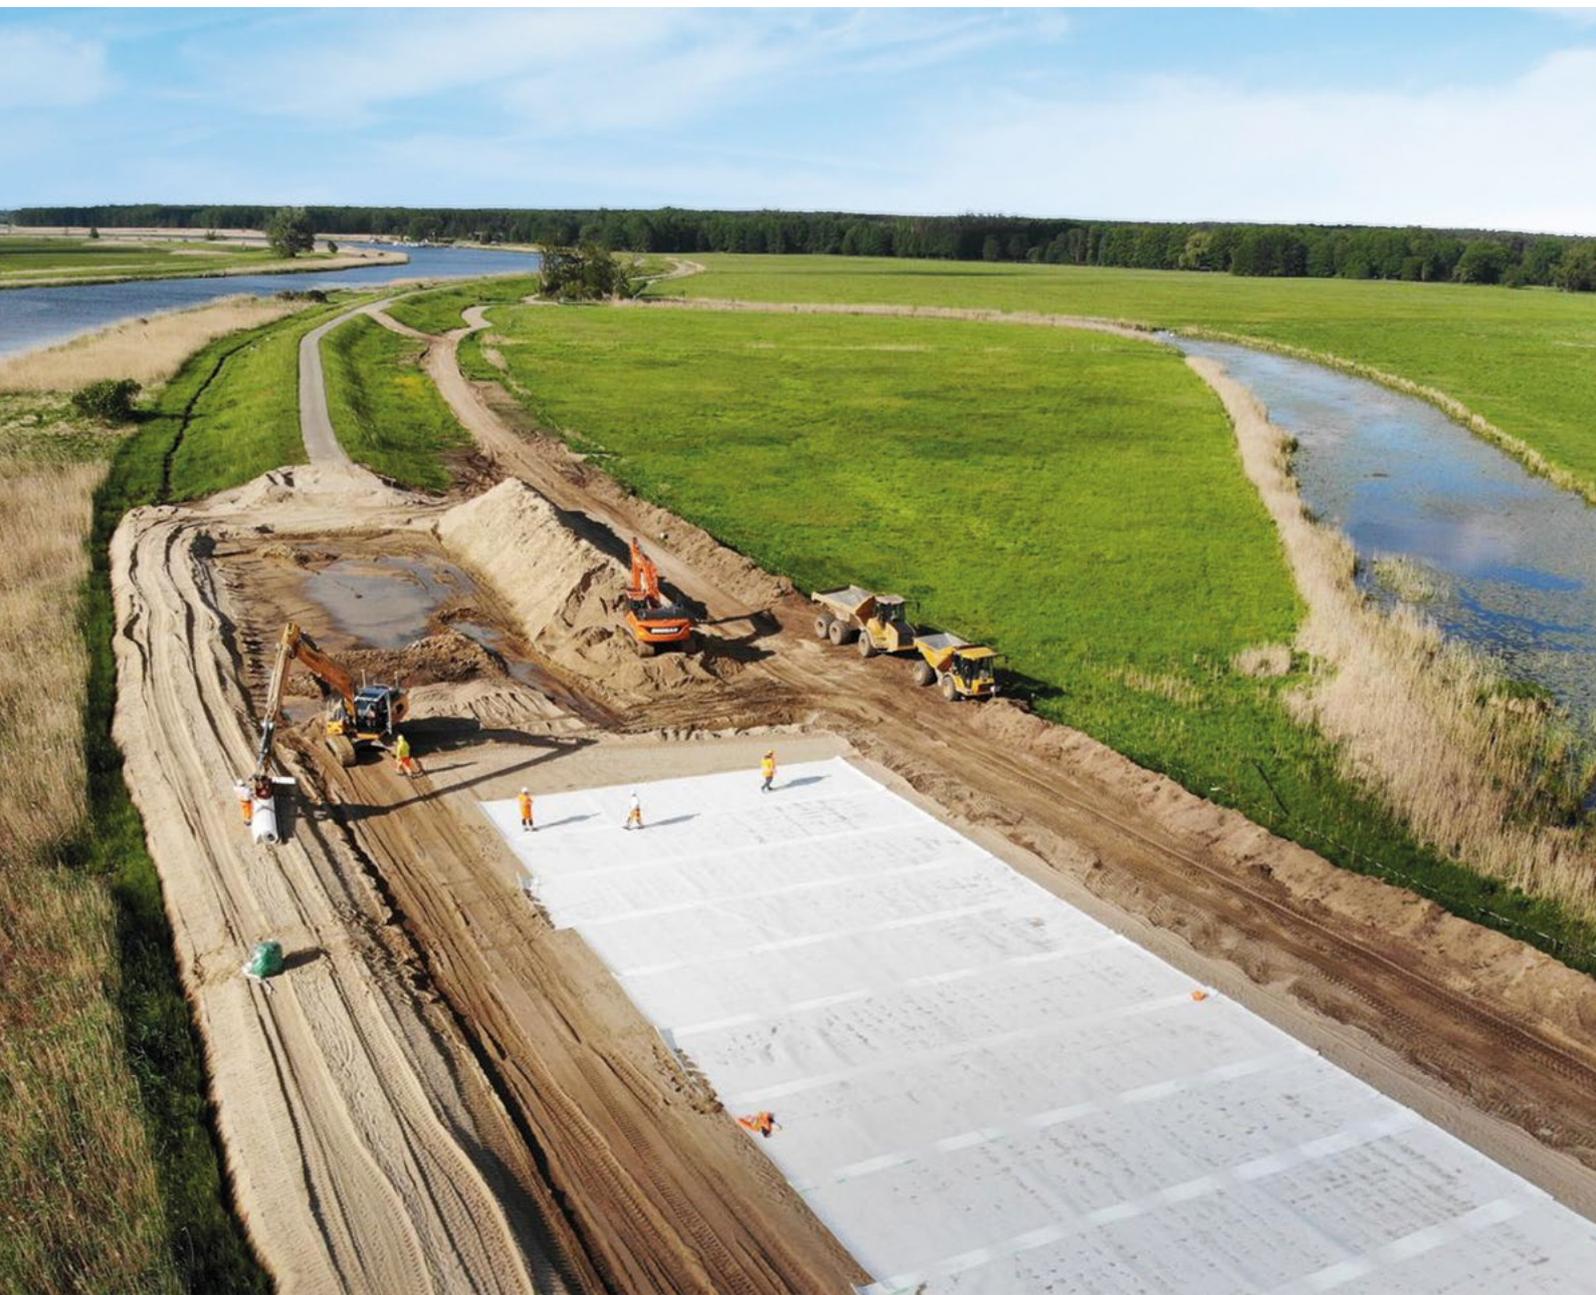
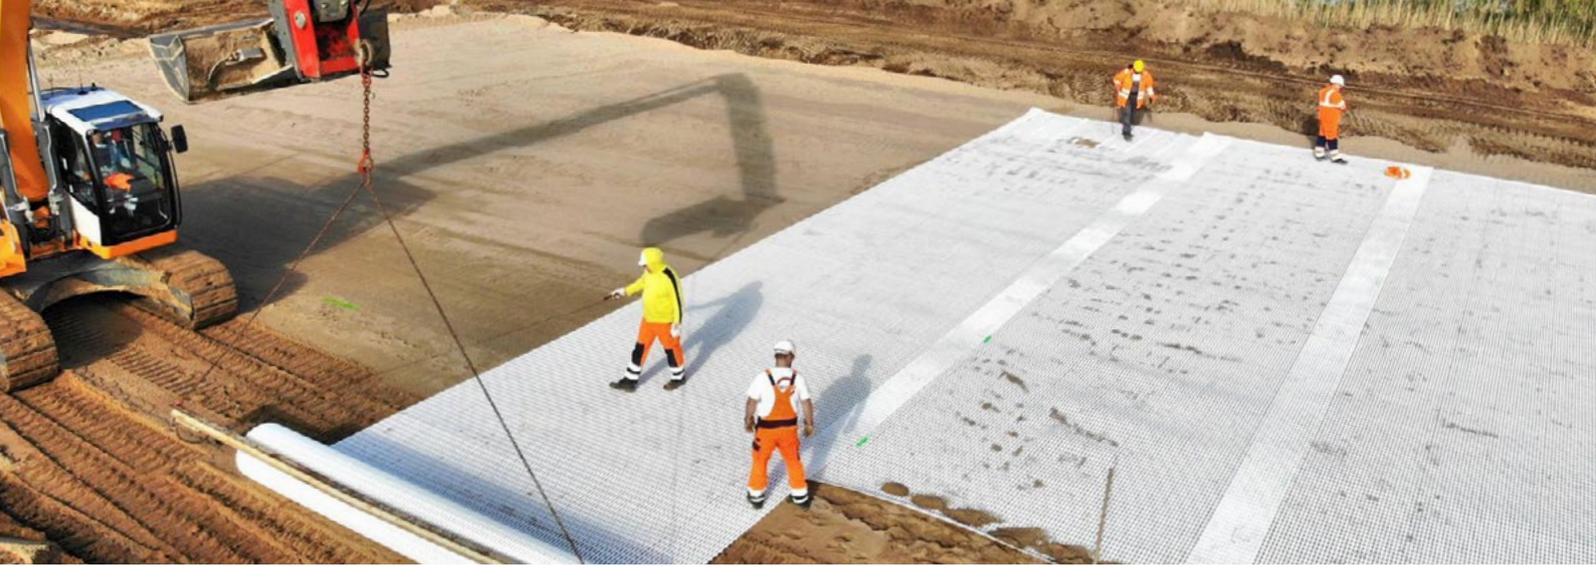
geogrid panels were installed with their main stress direction perpendicular to the dyke axis by using a spreader bar. Adjacent panels were overlapped by 50cm transverse to the direction of installation. Over the entire length of the dyke between Friedrichsthal and Gartz, a total of approx. 63,000 m² of the high-strength geogrid was installed.

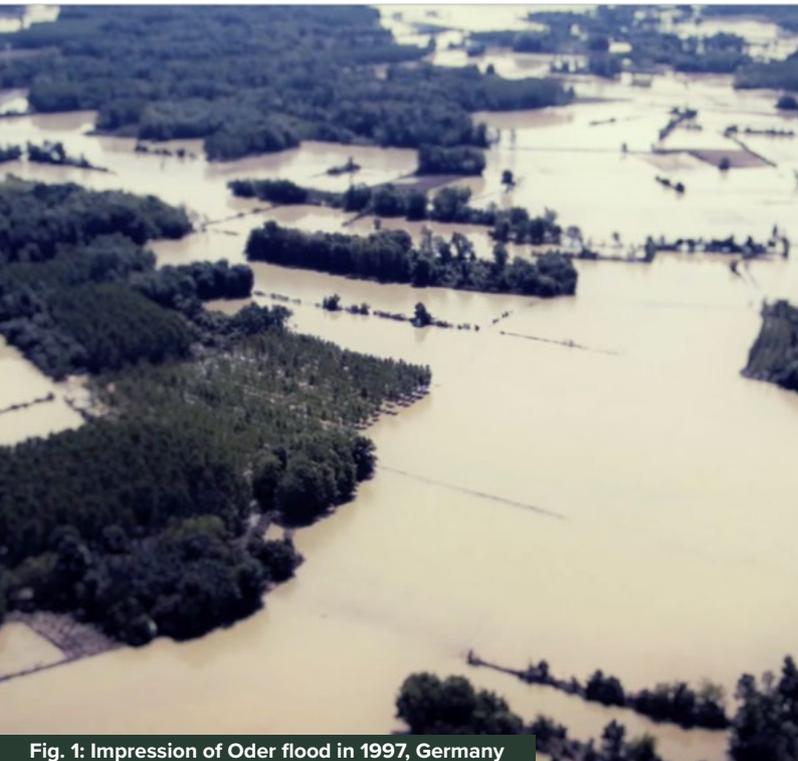
Fig. 1: Impression of Oder flood in 1997, Germany

In the summer of 1997, the largest known flood occurred along the German-Polish border river Oder. Due to the flood situation lasting several weeks, around 5,500 hectares of agricultural land and residential area with about 400 houses were flooded as a result of multiple dyke failures. Several thousand people had to be evacuated.

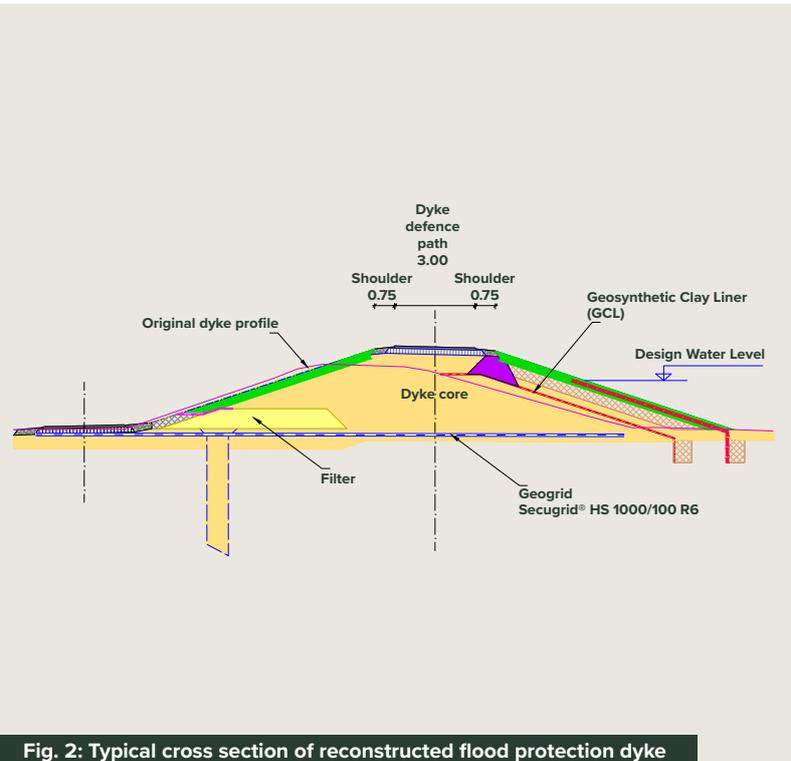
Fig. 2: Typical cross section of reconstructed flood protection dyke

The reconstruction of the dyke was carried out by partial removal of the old dyke and a reconstruction as a so called “3-zone dyke”. On the slope, facing the water-side, a geosynthetic clay liner (GCL) was installed as sealing system.
