# Secutex® Soft Rock

Coastal Protection

Project name  
Geotextile wall Lubmin, Mecklenburg-Vorpommern,  
Germany

Products  
Secutex® Soft Rock R 601

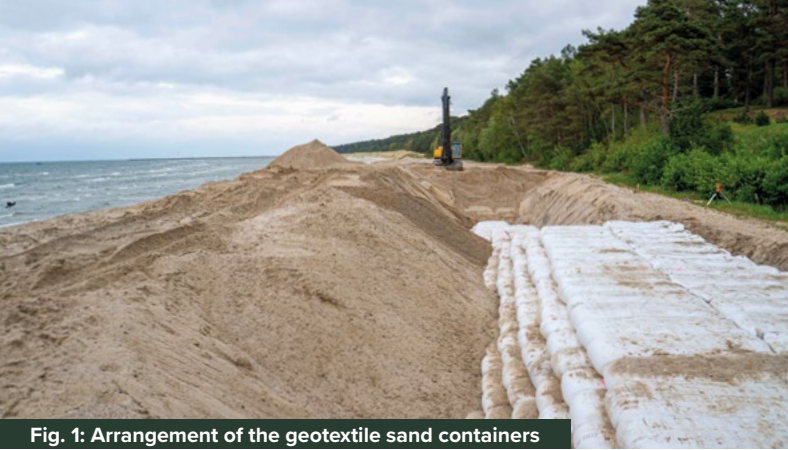
Fig. 1: Arrangement of the geotextile sand containers

The StALU quickly found a solution and used geotextile sand containers (GSCs) in the area that has to remain stable during a storm surge. After the sand had been removed, the geotextile sand containers Secutex® Soft Rock were placed. Stacked in an offset manner and inclined towards the land side, they form a so-called geotextile wall. Geotextile walls for dune reinforcement are covered by sand for most of their service life and appear natural. Only after severe erosion

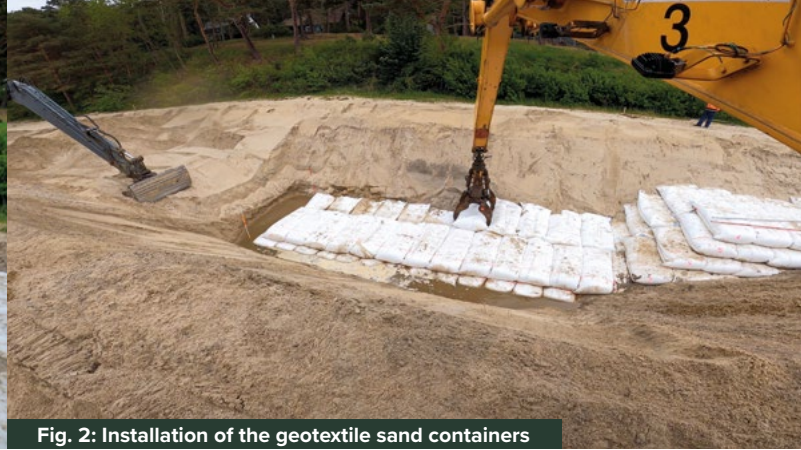
Fig. 2: Installation of the geotextile sand containers

Around 33,000 GSCs were installed to reinforce 1.8 kilometres of the dune along the coast of Lubmin. The executing contractor filled each container with one cubic metre of sand directly on the beach. A filled sand container weighs approx. 1.2 tonnes. The construction work was completed by the end of 2020.

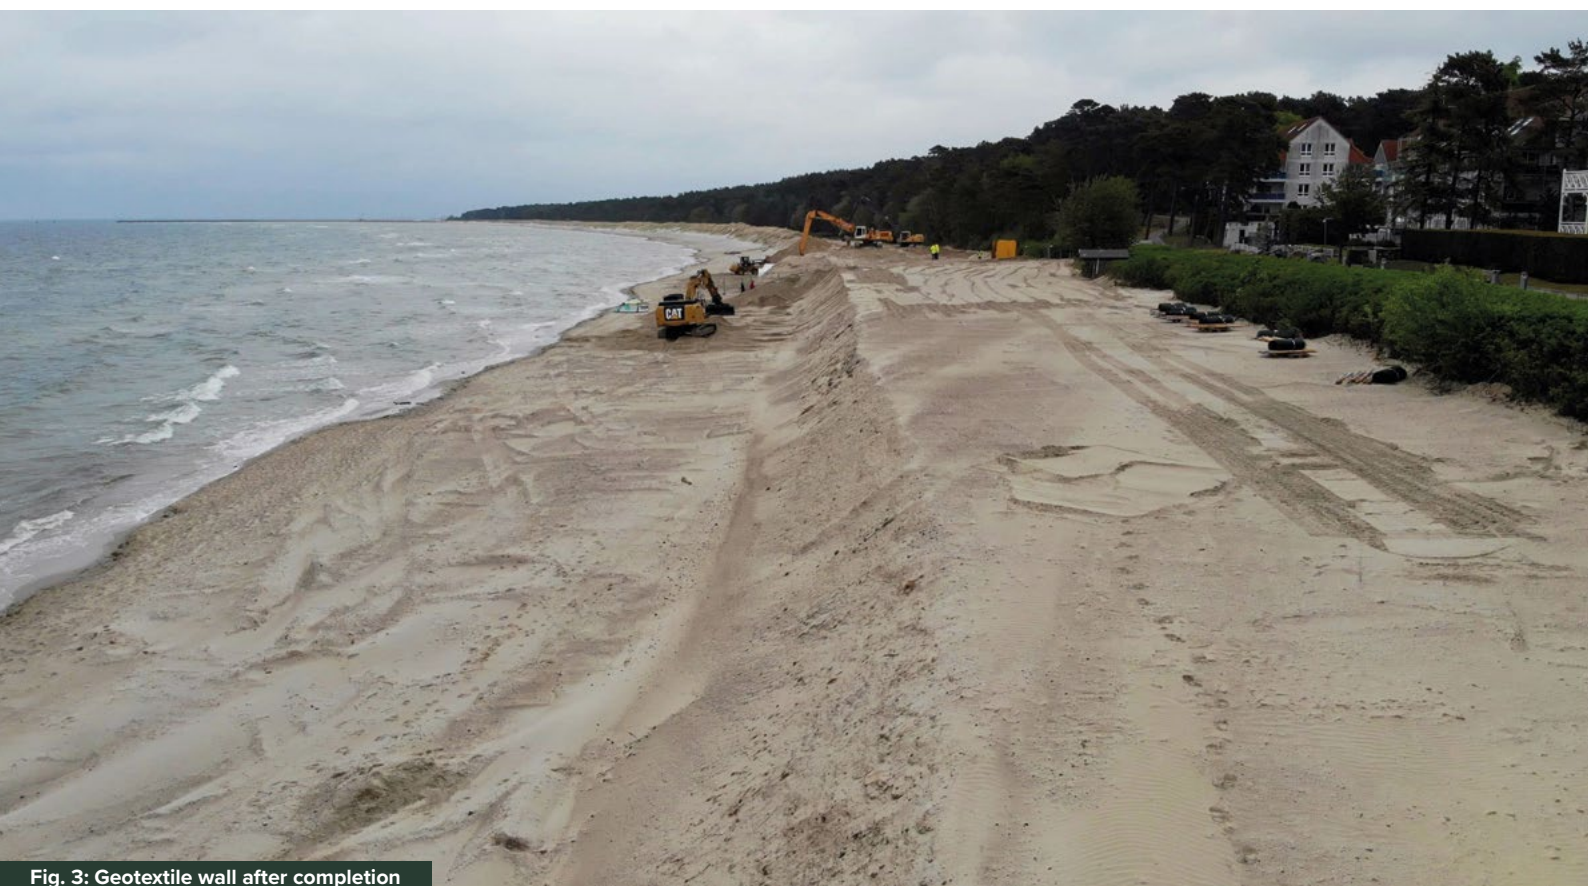
Fig. 3: Geotextile wall after completion

caused by one or more storm surges, the geotextile wall becomes visible again. After such a storm surge event, the dune is restored in its overall geometry and near-natural look.
