Erosion Control in a Drainage Channel with **SECUMAT®**

Project Name:
Heidlandgraben, Heykenauweg,
Hamburg, Germany

Products:
Secumat® 601 G4
Secutex® 301 GRK 5 C

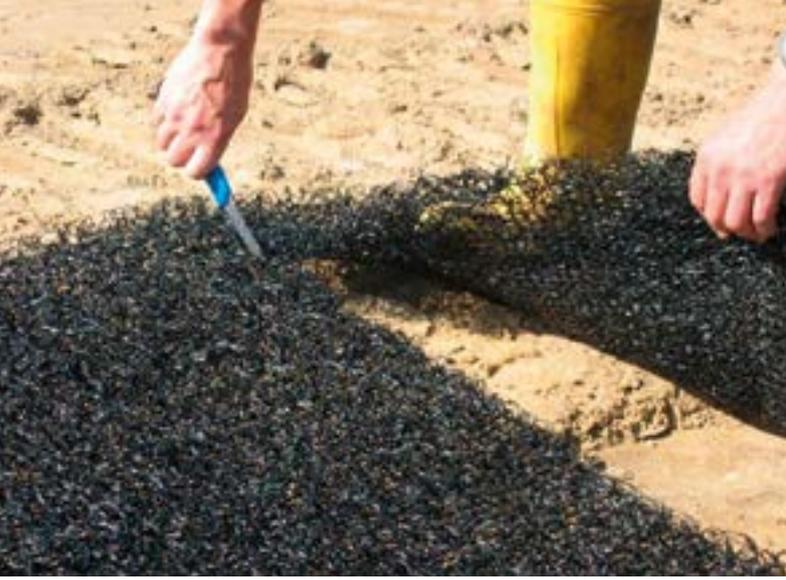
Fig. 1: Cutting of Secumat® on site

The erosion control mat was cut to size on site to the appropriate length for the slope (plus anchor trench). Due to its low weight, the material was installed by hand. The backfilling was carried out using a long arm excavator from the accessible side of the channel. Armourstones were placed in the bottom of the channel. To effectively prevent the sandy subsoil from being washed out through the coarse backfill even in the event of a substantial rise in the water level, a Secutex® separation and filter non-woven was installed on the subgrade in advance.

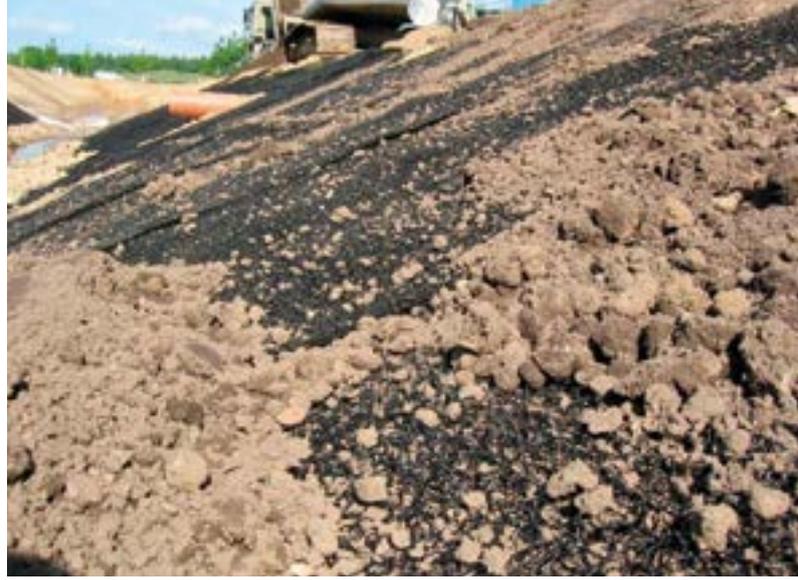
Fig. 2: „Interlocking“ of the topsoil with the artificial root network of Secumat® on the slope

The artificial, UV-stabilised root network of Secumat® products provided better support for the topsoil on the steeply formed slope flanks of the trench - especially during the construction phase, but also permanently after greening had taken place.

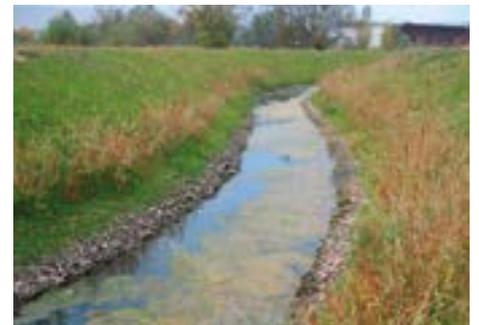
Fig. 3: Erosion-protected Heidlandgraben after completion with Secumat®

After completing the construction measure in 2007, the vegetation was able to establish itself on the embankments within a very short time. Even today, the slope flanks of the Heidlandgraben are very well protected by the installed Secumat® product and show no erosion damage.
