Erosion Control in a Drainage Channel

Project name
Heidlandgraben, Heykenauweg, Hamburg, Germany

Products
Secumat® 601 G4
Secutex® 301 GRK 5 C

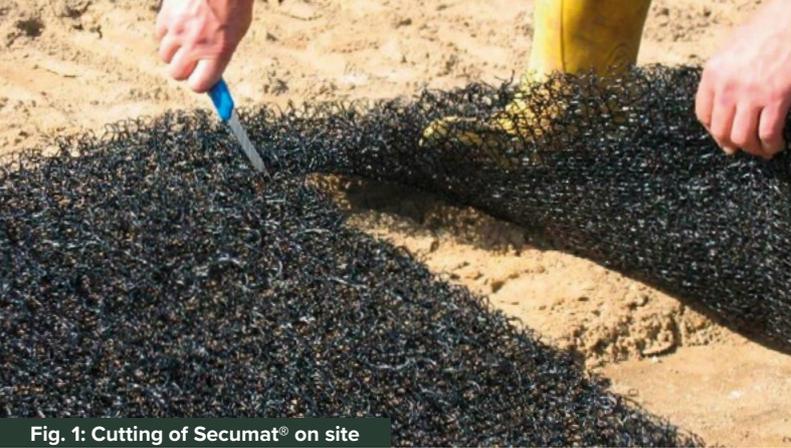
Fig. 1: Cutting of Secumat® on site

The erosion control mat was cut to size on site to the appropriate length for the slope (plus anchor trench). Due to its low weight, the material was installed by hand. The backfilling was carried out using a long arm

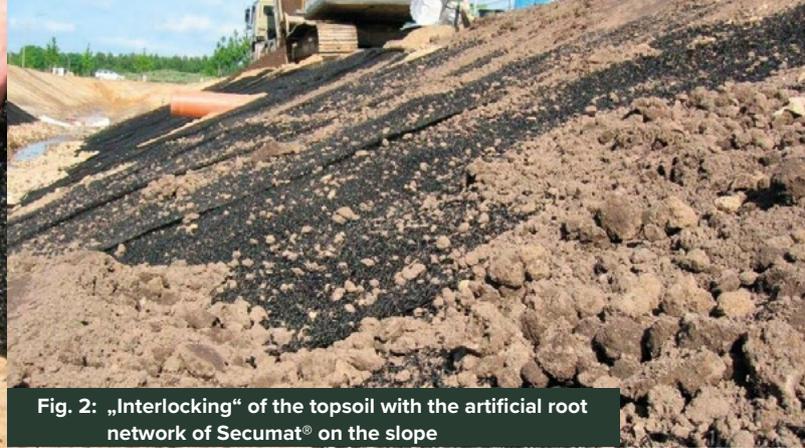
Fig. 2: „Interlocking“ of the topsoil with the artificial root network of Secumat® on the slope

The artificial, UV-stabilised root network of Secumat® products provided better support for the topsoil on the steeply formed slope flanks of the trench – especially during the construction phase, but also permanently after greening had taken place.

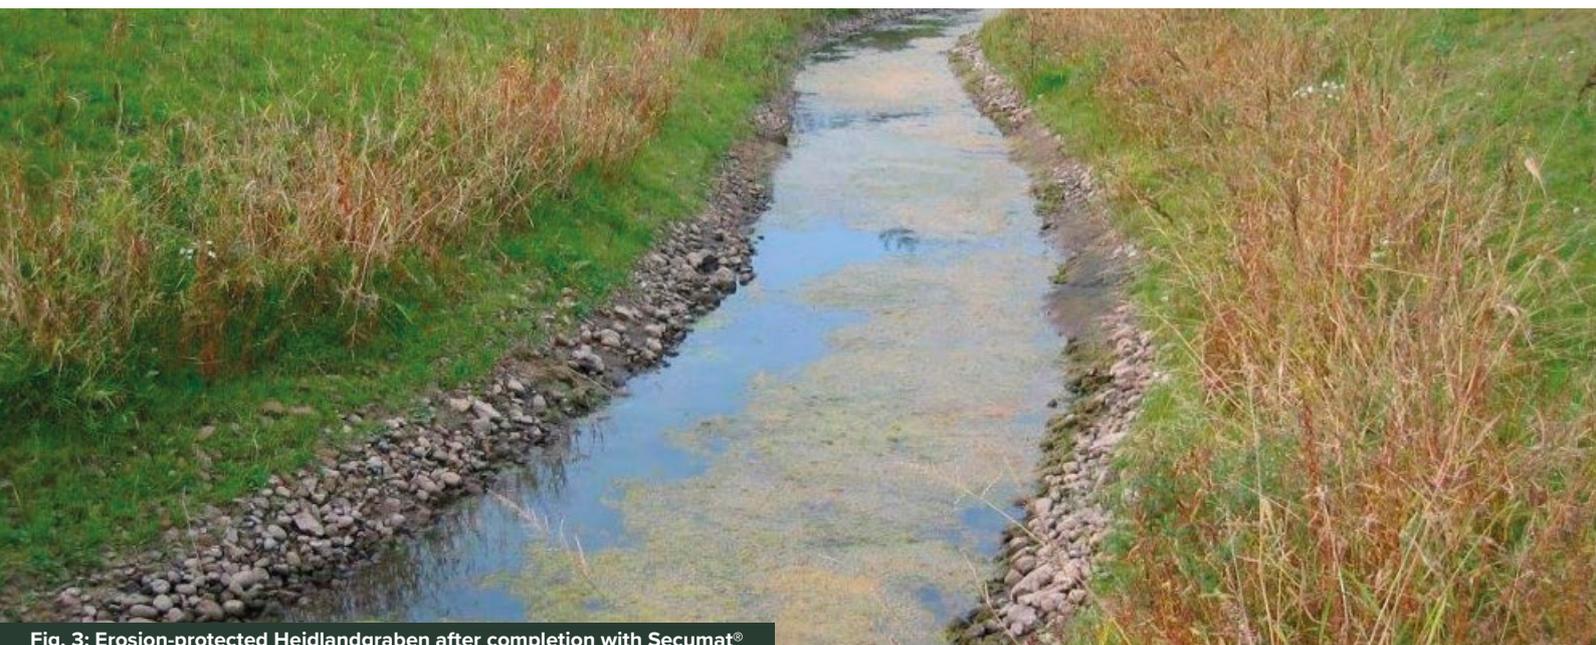
Fig. 3: Erosion-protected Heidlandgraben after completion with Secumat®

After completing the construction measure in 2007, the vegetation was able to establish itself on the embankments within a very short time. Even today, the slope flanks of the Heidlandgraben are very well protected by the installed Secumat® product and show no erosion damage.
