# Irrigation of orchards in Spain - Rainwater collection basin

- **Project name(s)**  
Rainwater collection basins in Teruel & Lleida, Spain
- **Client**  
Ecobalsas S. L., Lleida, Spain
- **Products**  
Carbofol® 406 1.5 mm s/s 7.50 m  
Secutex® HT 5

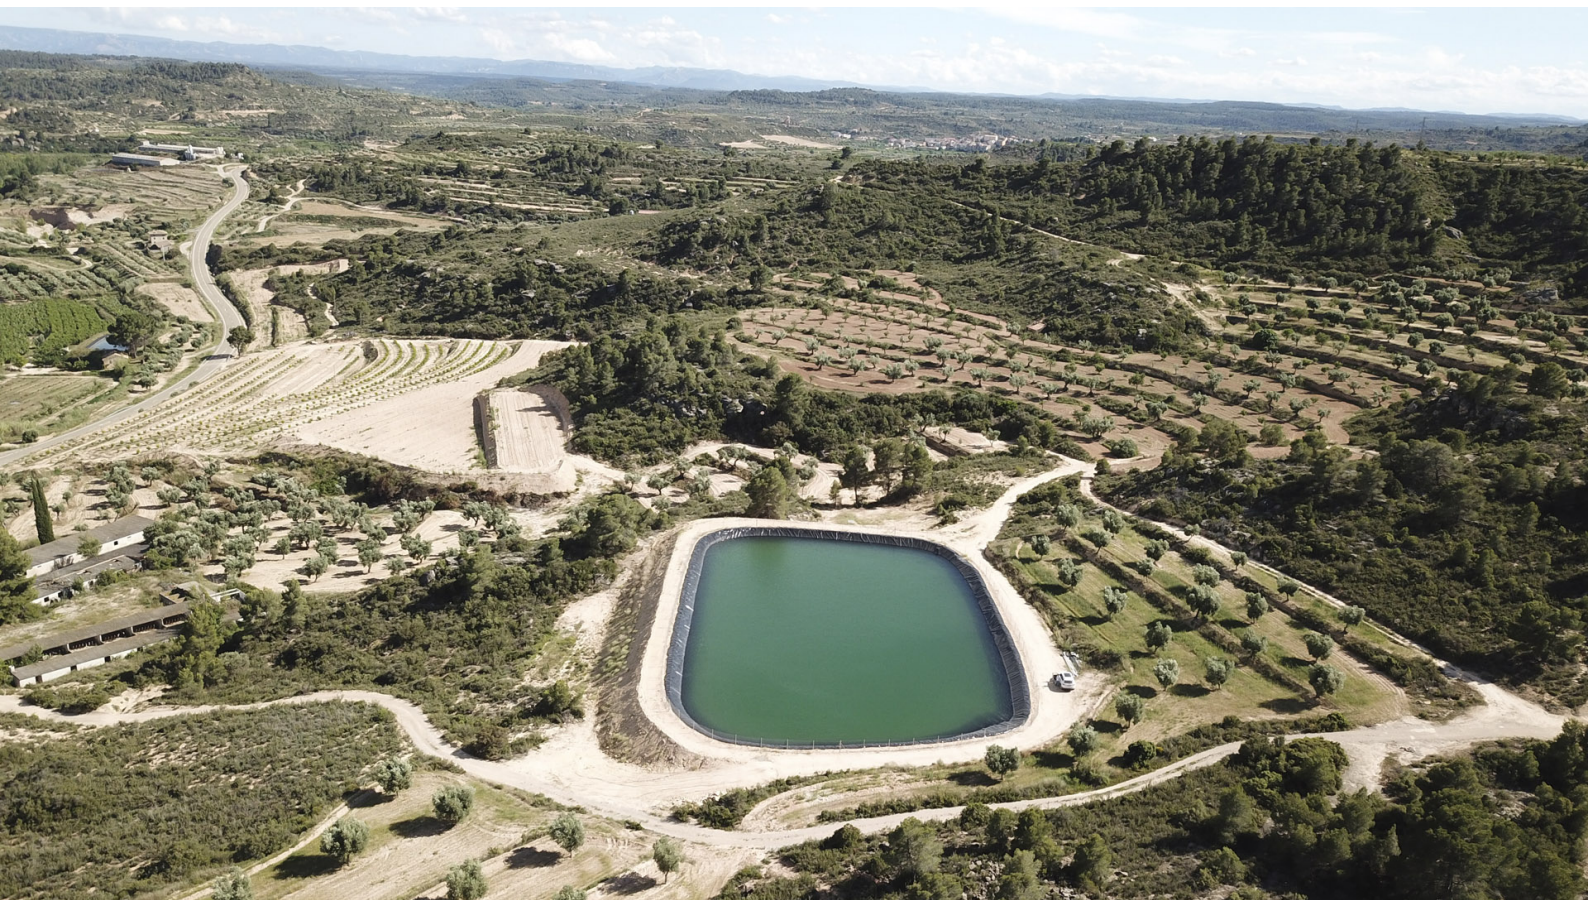
Fig. 1: Installation Naue Carbofol® on top of Secutex® nonwoven

The installation process is key to ensuring the longevity and efficiency of the rainwater collection basins. It begins with soil preparation, where the subsoil is compacted and sharp materials removed to prevent damage to the geomembrane. Next, a Naue Secutex® nonwoven geotextile is placed over the prepared ground. This protective layer prevents punctures and dust contamination before the Carbofol® geomembrane is installed. The membrane is joined using a double-welding method, creating an intermediate air channel for precise leak testing via air pressure. To maintain stability during installation, sandbags or other securing methods prevent wind uplift, ensuring the geomembrane remains in place until final covering layers are applied. This structured approach guarantees the long-term functionality of the reservoirs.

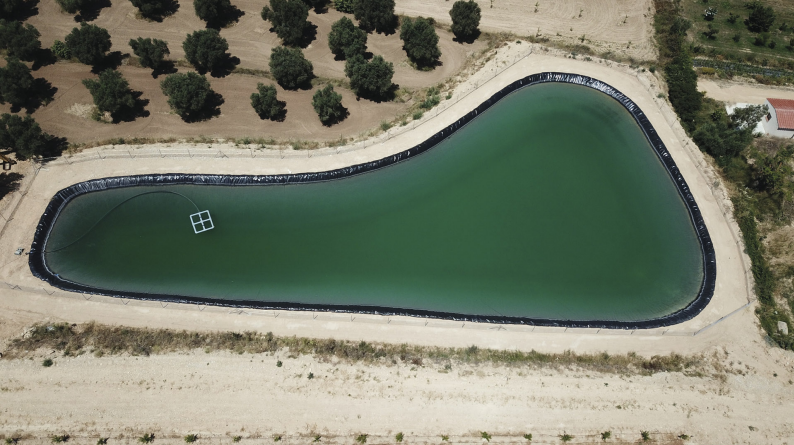
Fig. 2: Top view on irrigation pond
